## Daily Log: Thursday 6/20/2024

The Daily Log was completed by Noah Amidon on Sat, Jun 22, 2024 at 07:29 AM MDT.

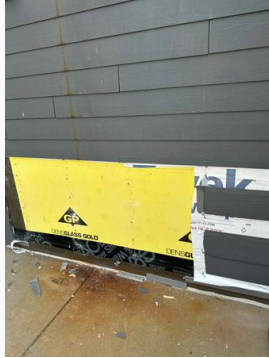
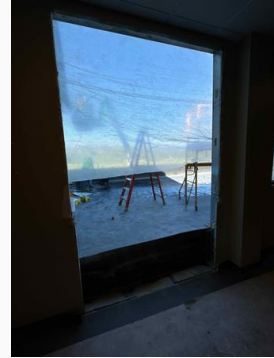
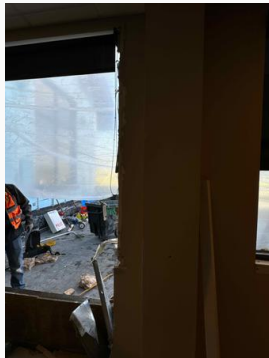
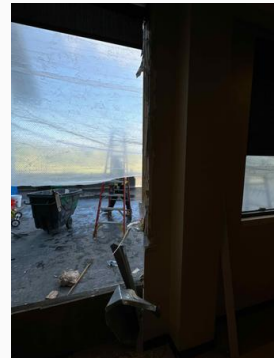
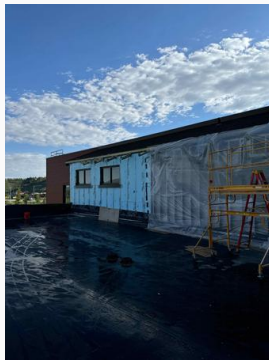
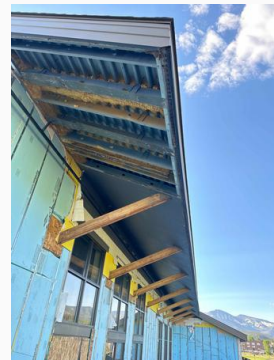
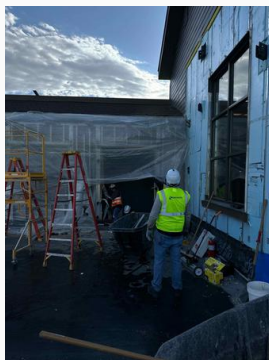
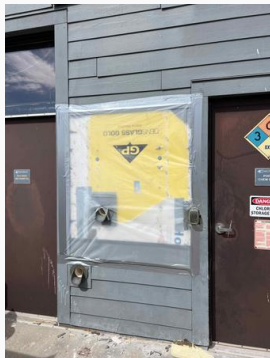
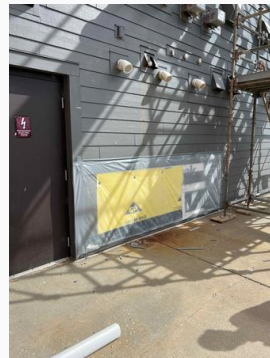
1. Engineered Demolition, Inc

No.	Contact/Company	Workers	# Hours	Man Hours	Location
1	Engineered Demolition, Inc	6	10.0	60.0	
<b>Comments:</b> Continuing demo at roof overhangs and cutting out opening at 212A. Also demoed siding sections at north and west sides on first floor to check for water damage to Dens Glass. The first floor densglass was found to be dry with no mold damage where demoed.					
2	PG Arnold Construction	2	10.0	20.0	
<b>Comments:</b> Waterproofed the first floor siding demo.					
		<b>8</b>	<b>80.0</b>
